**Conference on
Modern Technology trends in
Power Transformers including
OLTC, Bushings etc .
27-28 February 2019
CBIP Conference Hall, New Delhi**

**Modern Trends in Upper End of Windings and Lead Exit Insulation
Technology of HV Power Transformers , a Case study**

And there is a case study for the renewing of the HV Winding upper end insulation and with drip-proof seals, bellows and lead exit parts from a defect large power transformer, 400 kV, 125 MVA.

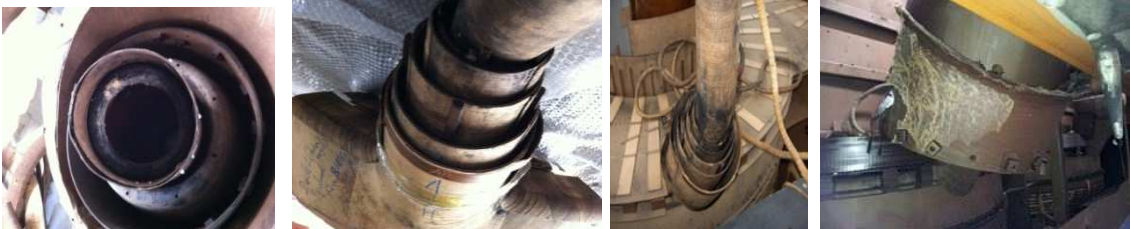
Figure9. Burned bellows and upper leads of HV winding

3 Ph. / 10, 5 kV/400 kV/125 MVA, Generator Transformer was in operation for 30 years. The upper insulation of HV windings, Lead exit part and the bushing faulted completely, which is shown in the pictures, figure 9-10. Major reason of insulation components breakdown was partial discharge (PD). In HV power transformers PD may occur due to over voltage, overheating, particles in the oil, deterioration of materials, loose connection, etc. (12), (15). Very often high moisture content in insulation can cause PD, significant reduction in dielectric strength, accelerated aging of cellulose. Monitoring and detection of PD is important task to keep the transformer in healthy condition. To prevent the ageing and moisture effect on the breakdown strength of insulation parts it is necessary to aim to steps. With the several diagnostics techniques can be estimate, moisture of oil, dissolved gas analysis (DGA), furans, degree of de polymerization (DP), polarization index and power factor.

We concentrate here to study and inspect the insulating parts and specially lead exit. Because the design of Lead exit must be changed and new lead exit must be produced, after dismantling of the pieces it was seen all of them was burn, Figure 9-10. The faulted old version was bellows type and with drip proof seal (14). Probable the sealing and connecting part was loose. End assembly of Transformer must check very carefully. The bellows was burned totally. Due to some leakage from drip proof seal and bellows comes humidity to inside. High water content in paper may result in bubbling, the formation of free water and an increased risk dielectric breakdown. Particularly the connecting and sealing part need high attention and

The case study gives information how to repair a 420 kV. 125 MVA power Transformer. Their upper part of insulation, lead exit and bushing was completely destroyed. All the HV winding upper part of insulations were renewed. The lead exit type was changed, because the old type was bellows type with drip proof, which was burned completely, due to leakage from sealing and from loose connecting part.

experience. According to the report of engineers in grid, bellows type was not preferable for new version. It is seen that the complete upper end insulations of HV windings with Lead exits were faulted, (15). We illustrate here in Figure 9-10 the damaged upper insulation parts and the lead exits in detail, (16-17).

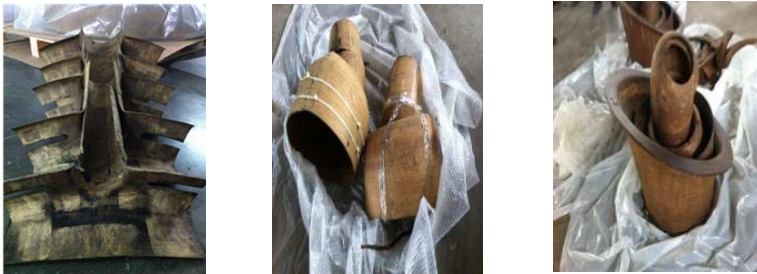
Figure10. Burned snouts, electrodes, bellows

The Bushings were also faulted and changed with new units (18). In some places subjected to a low electrical stress may have inherently high dielectric losses. These losses can mask problems in the main oil barrier insulation space. It is seen on all faulted insulation parts are occurred by the creeping discharge on the surface and carbonized traces (19).
