**Conference on
Modern Technology trends in
Power Transformers including
OLTC, Bushings etc .**

**Modern Trends in Upper End of Windings and Lead Exit Insulation
Technology of HV Power Transformers , a Case study**

Selim Yurekten, CIGRE Distinguished Member, TR Member IEEE
ENPAY Transformer Components

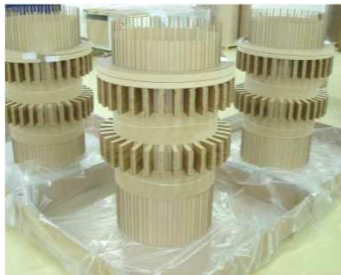
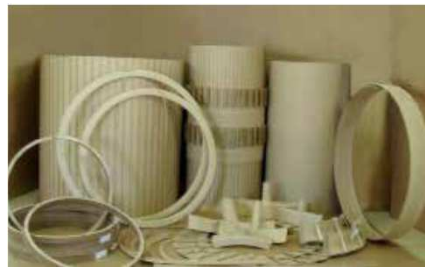
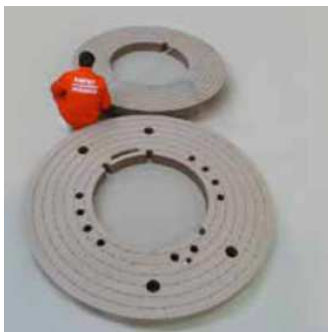
In the solid insulation system of the ends of windings are: angle ring/caps, snouts, clamping rings, spacers, strips, shield rings, lead exits.

Short circuits tend to compress the windings. The forces should distribute on clamping rings equally. Clamping rings used to clamp the windings

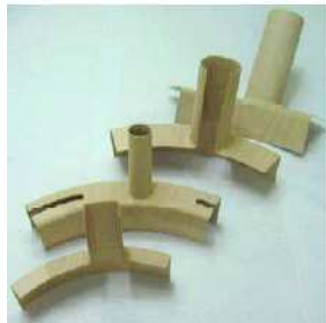
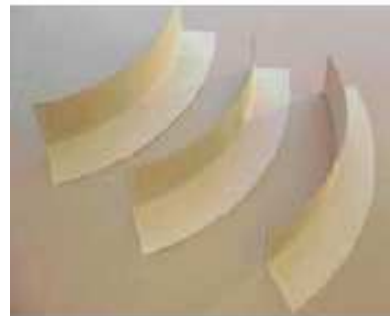
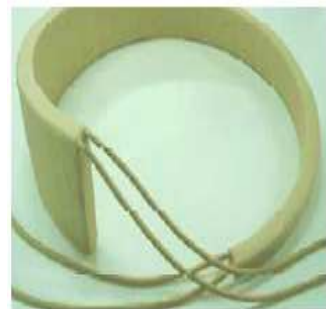
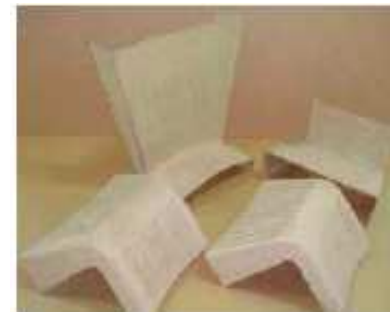
The pictures below shows some parts of upper insulation system

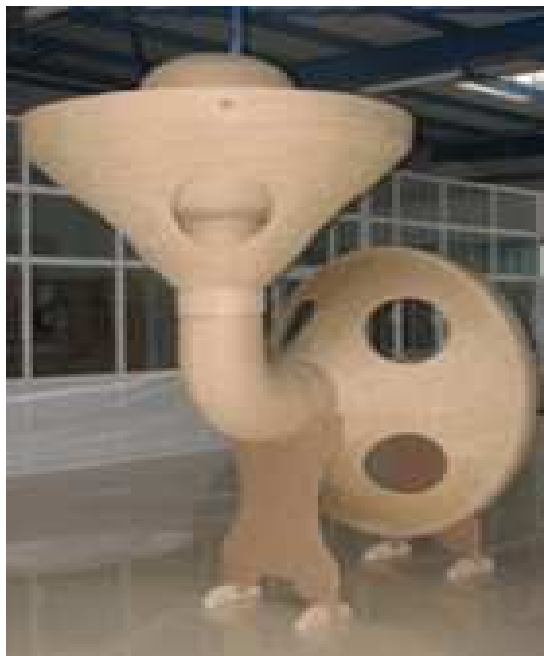
Typical design of the Lead Exit which is going from mid of the winding.

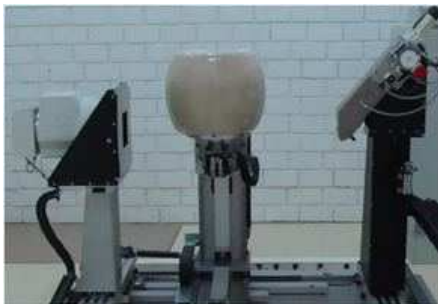
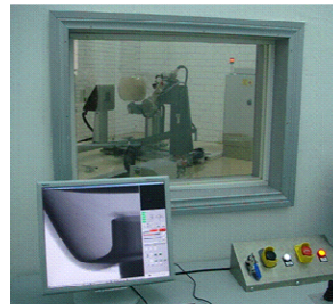
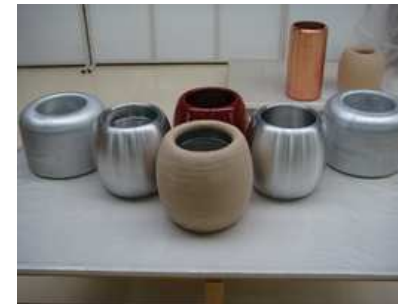
In the following pictures are the **X-RAY testing** procedure after insulating with wet mold insulation .

Metal particles or air bubbles can be checked **in computer screen** , which disturb electrical field.

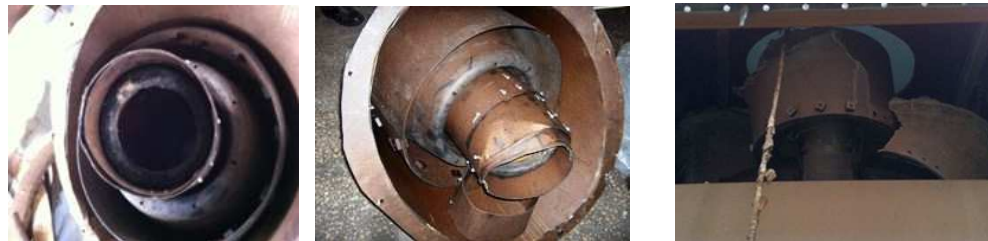
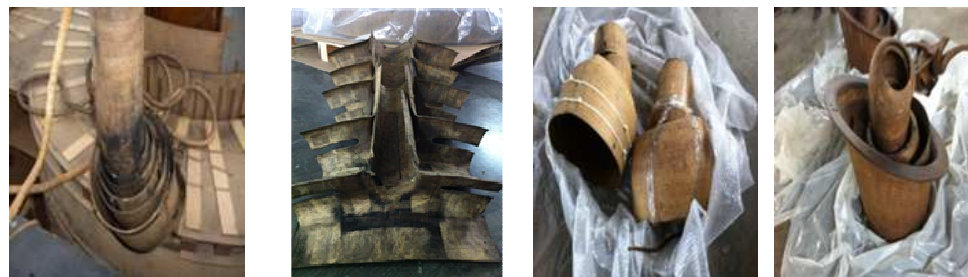
The **upper insulation** of HV windings, **lead exit** and **bushing** faulted completely.

Major reason of insulation breakdown was **(PD) partial discharge**.

Due to leakage from drip proof seal and bellows comes moisture from outside.

The pictures below shows the defected parts, some of them were burned completely.

The bushings were also faulted and changed with new units.

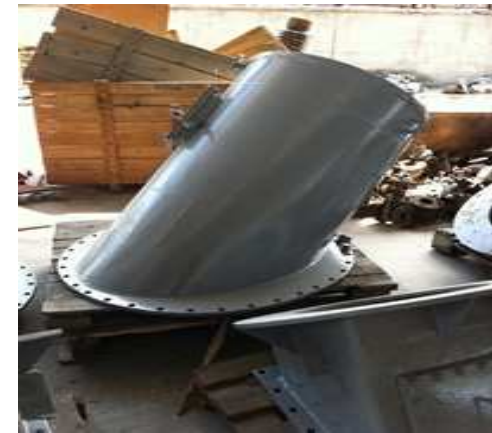
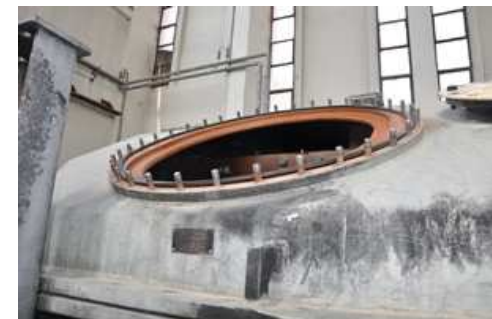
The new design of lead exit started to analyze the dielectric fields. It is used the FEM program .

After FEM 2D electrical field calculation, the design of lead exit can be realized. **According new instruction of Grid, the Bellows were not used.** For all 3 phases designed separately.

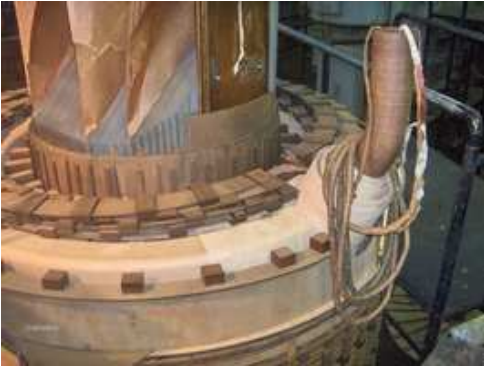
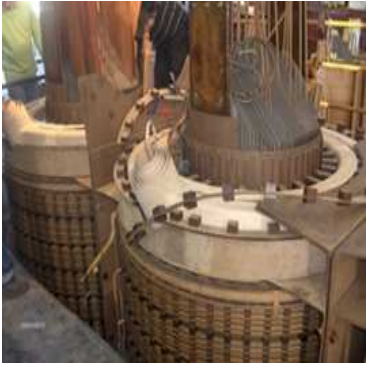
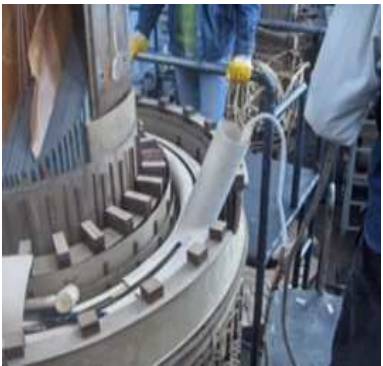
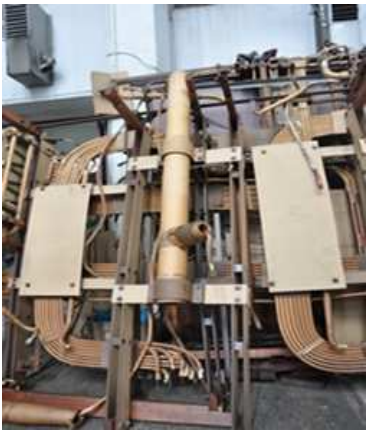
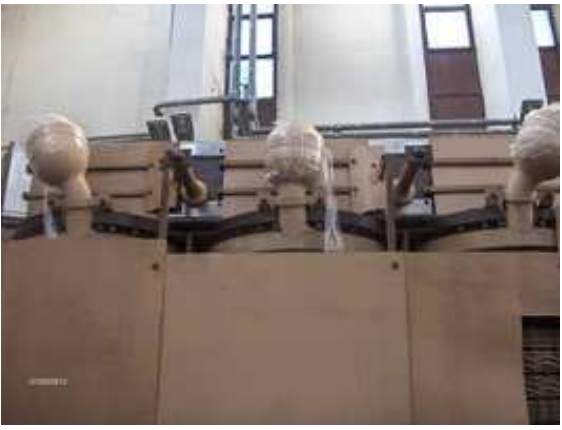
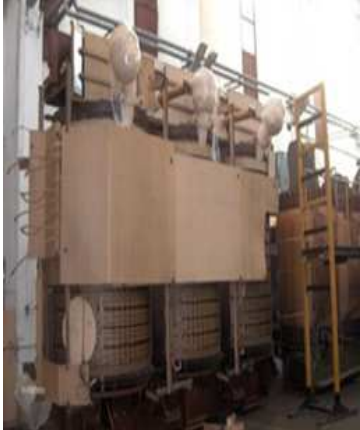
The pictures below shows end montage of the new insulations system.

After testing of the transformer putted in operation.
